Subject: **Front/Rear Door Seals, Friction Noise**

Number: **97-02**

Date: **July 29, 1997**

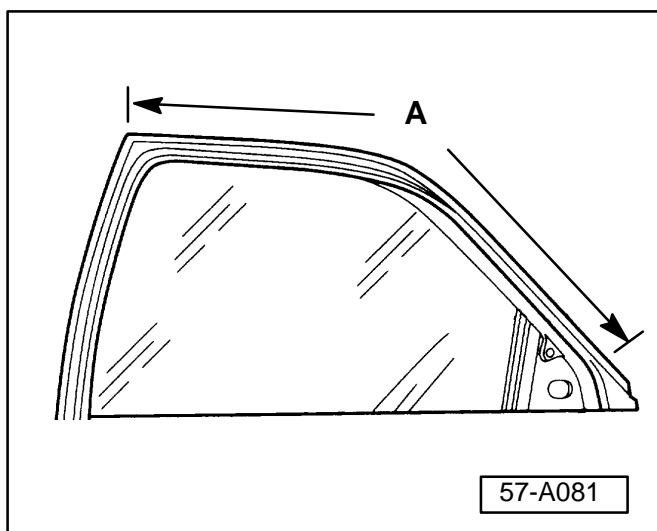
Noise heard while driving over uneven surfaces caused by friction between door sealing surface and the roof molding.

- ◀ – Install isolation tape along **-A-** on **front doors** where the door edge contacts the roof molding.
- ◀ – Install isolation tape along **-A-** on **rear doors** (if applicable) where the door edge contacts the roof molding.
- Road test vehicle to assure noise has been eliminated.
